OTC 18989

Fixed Platform Performance During Recent Hurricanes: Comparison to Design Standards

F. J. Puskar, S. M. Verret, C. Roberts, Energo Engineering, Inc.

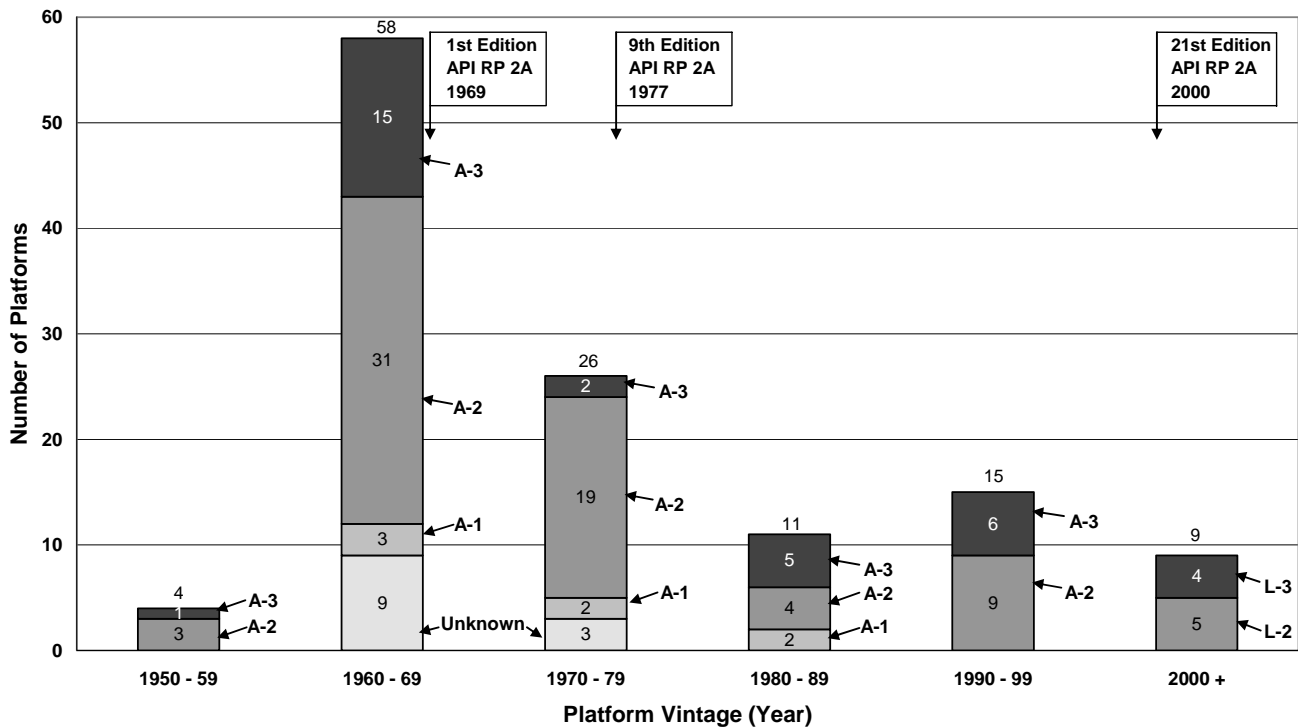
Figure 2: Ivan, Katrina, Rita Platforms Destroyed by Vintage

Figure 2 shows the number of destroyed platforms by vintage according to decade. The 1st edition of RP2A released in 1969, the 9th edition in 1977 and the current 21st edition in 2000 are also shown. It is clear that over time the platform structural designs have been improved. There is a dramatic reduction in destroyed platforms from the 1960's to the 1970's as platforms began to follow RP2A. There is another significant reduction in destroyed platforms between the 1970's and 1980's as the 9th edition was introduced – including its improved wave load recipe. A total of 35 platforms that were installed since 1980 were destroyed; however, about 30% were A-3 and another 10% were L-3, both being minimal low consequence facilities. These platforms generally contain a single well or a few wells that are often designed to reduced criteria. Twice as many platforms were destroyed that were installed in the 30 year period from 1950 to 1980 compared to the 25 year period from 1980 to 2005. The single largest failure group is the 1960 vintage platforms, which account for almost one half of the total destroyed.

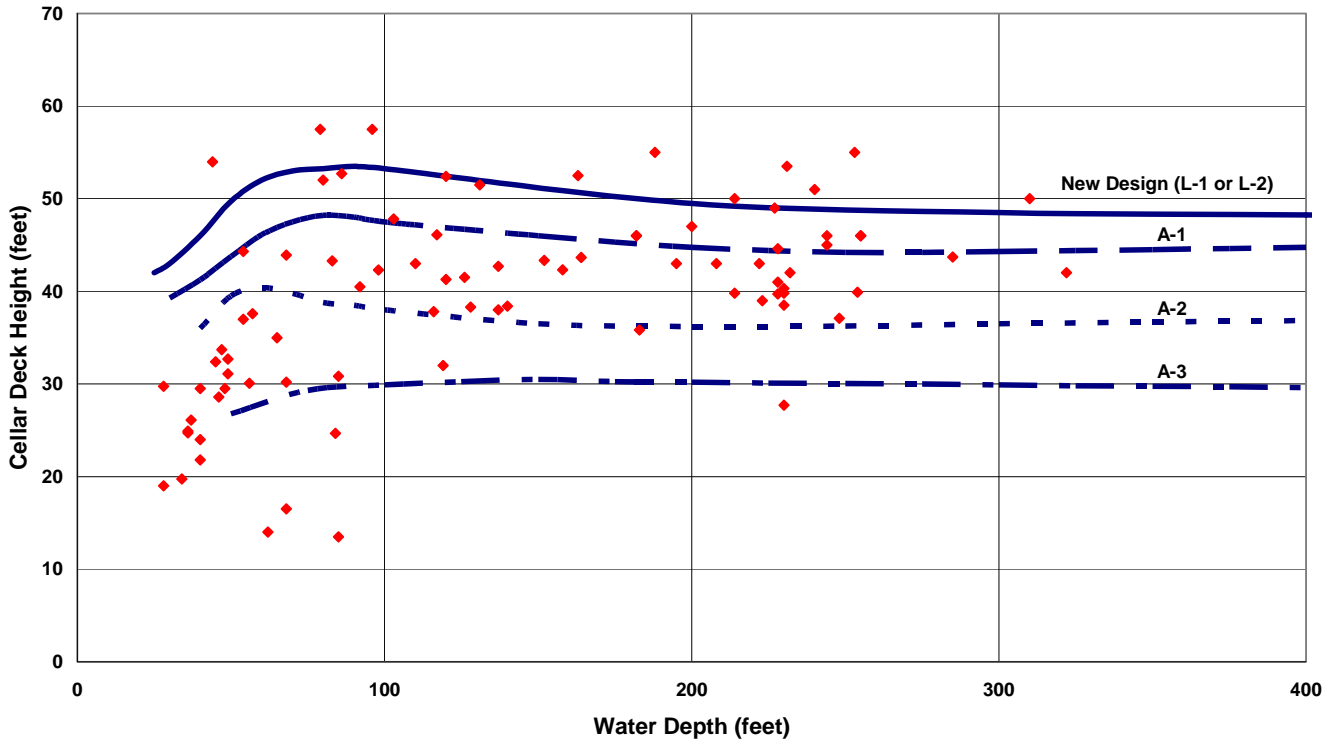
Figure 3: Ivan, Katrina, Rita Platforms Destroyed by Deck Height [3]

There were only seven A-1 platforms destroyed. This is in part due to the higher Section 17 strength and deck elevation requirements for a platform to be designated as A-1. Figure 3 shows the cellar deck elevations of the destroyed platforms compared to the RP2A minimum deck elevation requirements. The deck elevation was available on most but not all of the

destroyed platforms so not all of the destroyed platforms are shown. As shown by the figure, a majority of the destroyed platforms had deck elevations less than the A-1 requirement. A wave crest hitting a platform deck creates a very large load that will likely result in significant platform damage and in many cases collapse. Hence a key ingredient in surviving hurricanes is to have a deck elevation above the largest hurricane waves. API is currently investigating minimum deck elevation requirements and an update to RP2A is possible. A more detailed comparison of deck elevations to RP2A criteria for these hurricanes is contained in OMAE 2007 [3].

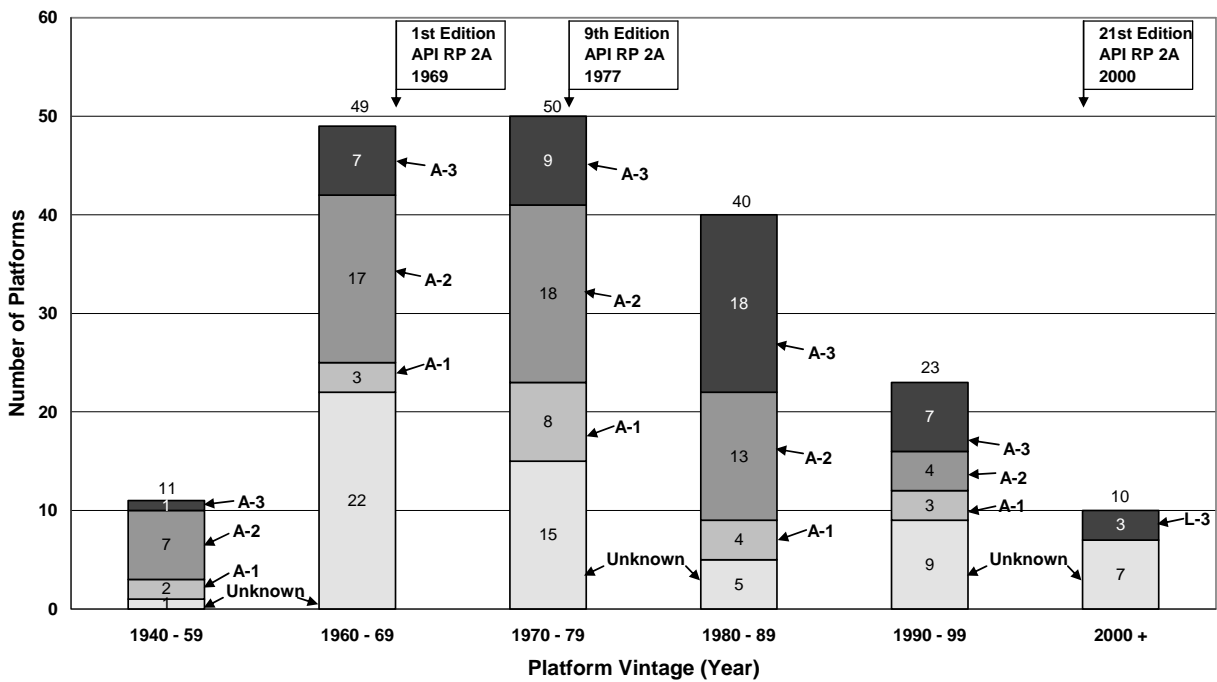
Figure 4: Ivan, Katrina, Rita Platforms Major Damage by Vintage

Figure 4 shows the number of platforms with major damage as function of decade installed. The figure also shows the number of platforms according to API consequence category. Major damage was defined as significant damage either below or above water or both. Damage below water included separated or torn members, cracked members, members with numerous holes, dents or a combination of these, cracked welds, missing members or buckled members. Damage above water includes broken and separated deck members, damage to deck girders from wave crest loading and other types of damage to primary deck structure. As seen in Figure 4, there is a reduction in the number of damaged platforms from 1970 onward, but the reduction is not as dramatic as for destroyed platforms. One explanation is that the older platforms have less damage tolerance, and hence are more likely to be destroyed, while the newer platforms have higher damage tolerance, and are more prone to damage than destruction. Similar to the destroyed platforms, the A-2 platforms have the most damage, followed by A-3 and then A-1. An important point is that there were no L-1 platforms damaged, indicating again the exceptional performance of the L-1 platform designs.

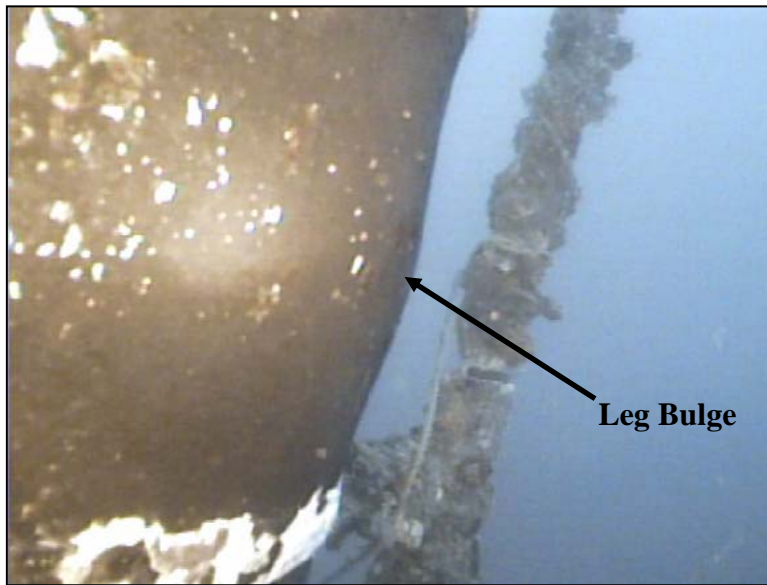
One type of unusual damage that has occurred in several cases has been tentatively called “pancake leg” due to the flattening of the leg in the damaged area point. This damage was first observed in Lili, and then again in Ivan, and was originally thought to be caused by fabrication flaws. But there are now over 12 confirmed instances of this type of failure since hurricane Lili. In addition, there may be similar damage that has not yet found, and this damage may be present on some of the destroyed platforms, or may in fact have been the reason for the platform failure. The damage is believed to develop as a result of the significant stiffness change between the thin walled nominal section of the jacket leg and the thicker joint can section at the horizontal elevations. In the majority of the cases studied, the thinner nominal leg thickness is thinner 1/2 to 5/8 inch wall thickness and the joint cans are 1 to 1 1/2 inches thick. In all cases, the pile was not grouted to the leg.

Figures 5 to 7 show what is believed to be the progression of the damage from initial bulging/buckling to the final pancaking of the leg. Figure 5 shows the initiating local buckle in the thin wall leg section just above the thicker joint can. Figure 6 illustrates the next phase of the damage. This damage is usually found near a longitudinal weld seam, although this is being further verified. The jacket leg begins to acquire more of the loading and usually separates within the heat affected zone between the two differing wall thicknesses. The pancaking of the leg occurs after the leg is severed. This is illustrated in Figure 7. The constant back-and-forth wave motions and resulting platform movement cause the platform

Figure 5: Pancake leg initial mechanism - Leg bulge caused by local buckling in the thin wall nominal leg region

Platforms with exceptionally thin nominal leg thickness (on order of 1/2 inch) and thick joint cans can be prone to this type of damage. This damage can be easily prevented in advance by grouting the leg-pile annulus. Operators should consider this mitigation for their more important platforms that are prone to this type of damage. Additional information can be found in MMS TAR Project No. 578 [8].

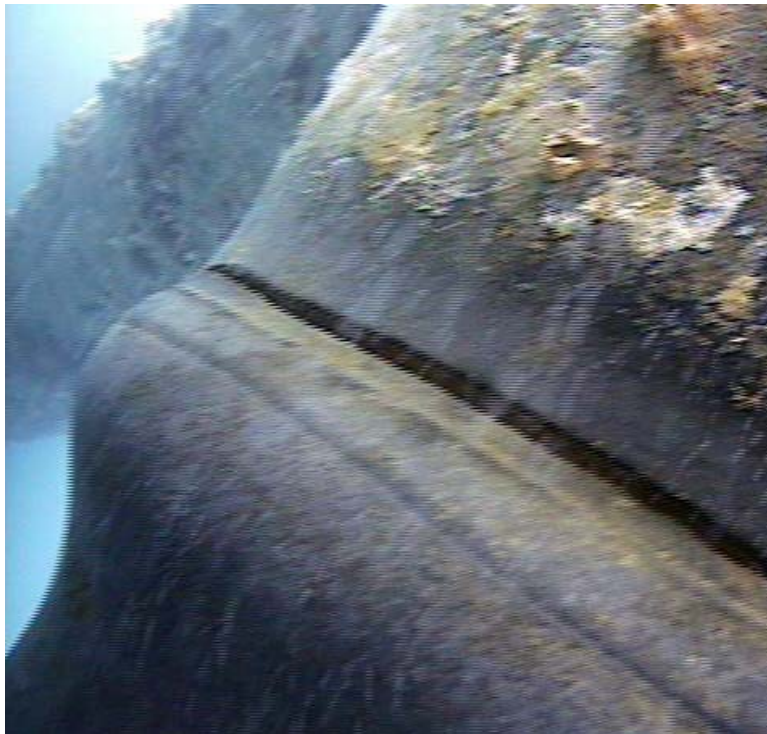
Figure 6: Severed leg section just above the bulge. Note the longitudinal weld seam just below the sever.

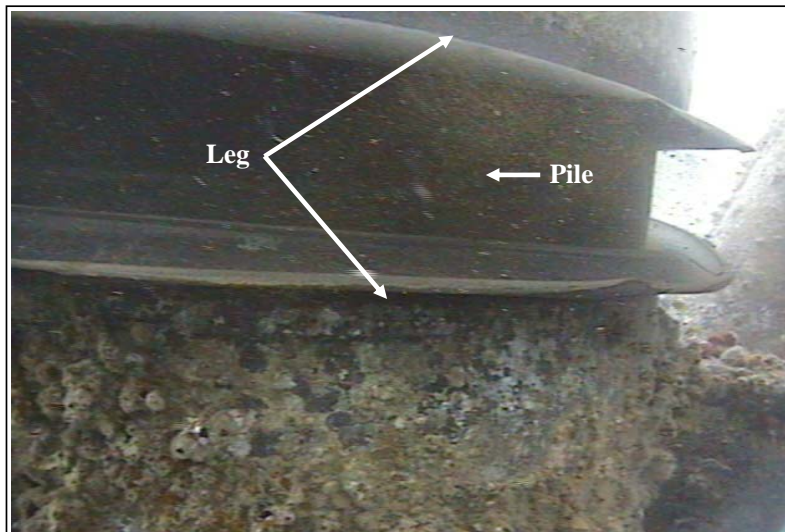
to move and “pound” the separated sections into each other resulting in the flattened pancake region. Of the cases studied, the majority of platforms usually had additional jacket damage such as broken joints or buckled braces. The majority of the damage found within the damaged structures consists of separated or torn members, separated X-braces, or a combination of both. This additional damage is believed to allow the platform to incur the movements required to pound the leg flat. Conversely, this additional damage results in platform movement or load redistribution which then triggers the initial leg buckle. This is still being studied. In some cases the pancaking is exceptionally flat as shown in this example, where the pancaking is similar in shape to an external hydrostatic ring stiffener. In other cases, the pancaking is less flat, although it is clearly the same phenomena. Most of the platforms with this type of damage were repaired or are considering repair, although the repair can be costly.

Figure 7: Leg Pancaking. Note the leg has severed and exposed the pile inside the leg
