**OMAE 2007-29633**

**PERFORMANCE OF STEEL JACKET PLATFORMS IN RECENT  
GULF OF MEXICO HURRICANES**

**ABSTRACT**

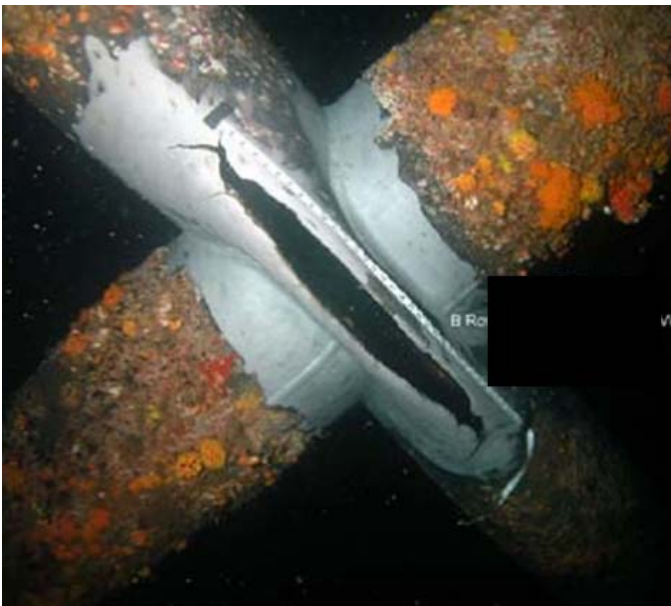
Detailed review of some of the 1970's vintage platform damage indicates that it occurred in some of the key joints. Had these joints had even a slightly thicker wall thickness, as called for in the present RP2A, several of these platforms would have escaped these hurricanes with little or no damage. Figures 3 and 4 show examples of damage to an X joint and a T joint of 1970 vintage platforms that had insufficient joint wall thickness and the joints failed. These joints were repaired and the platforms returned to service.

FIGURE 3 – DAMAGED X JOINT DUE TO INADEQUATE JOINT CAN THICKNESS

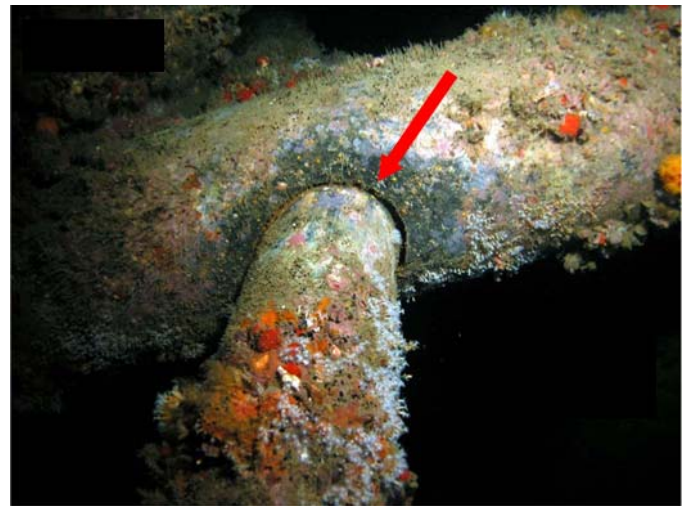
FIGURE 4 – DAMAGED T JOINT DUE TO INADEQUATE JOINT CAN THICKNESS

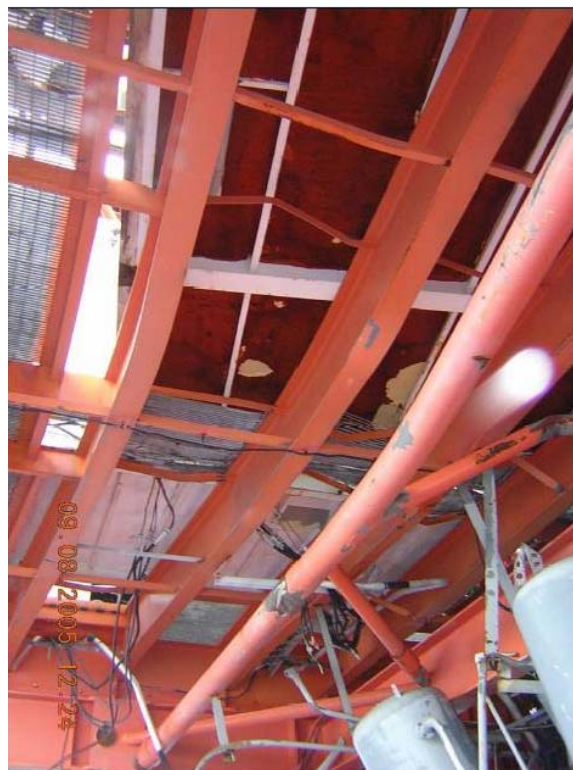
There has been much discussion in the offshore industry about the amount of damage to platform decks due to wave impact from these hurricanes. Figure 6 shows an example of this type of damage that was observed on a platform at elevation (+) 73'-0" from MLLW. Note the horizontal tubular and the wide flange beams bowed towards the right side of the picture.

FIGURE 6. MAJOR DAMAGE TO DECK STRUCTURE DUE TO WAVE IMPACT
