**OMAE 2007-29633**

**PERFORMANCE OF STEEL JACKET PLATFORMS IN RECENT  
GULF OF MEXICO HURRICANES**

**ABSTRACT**

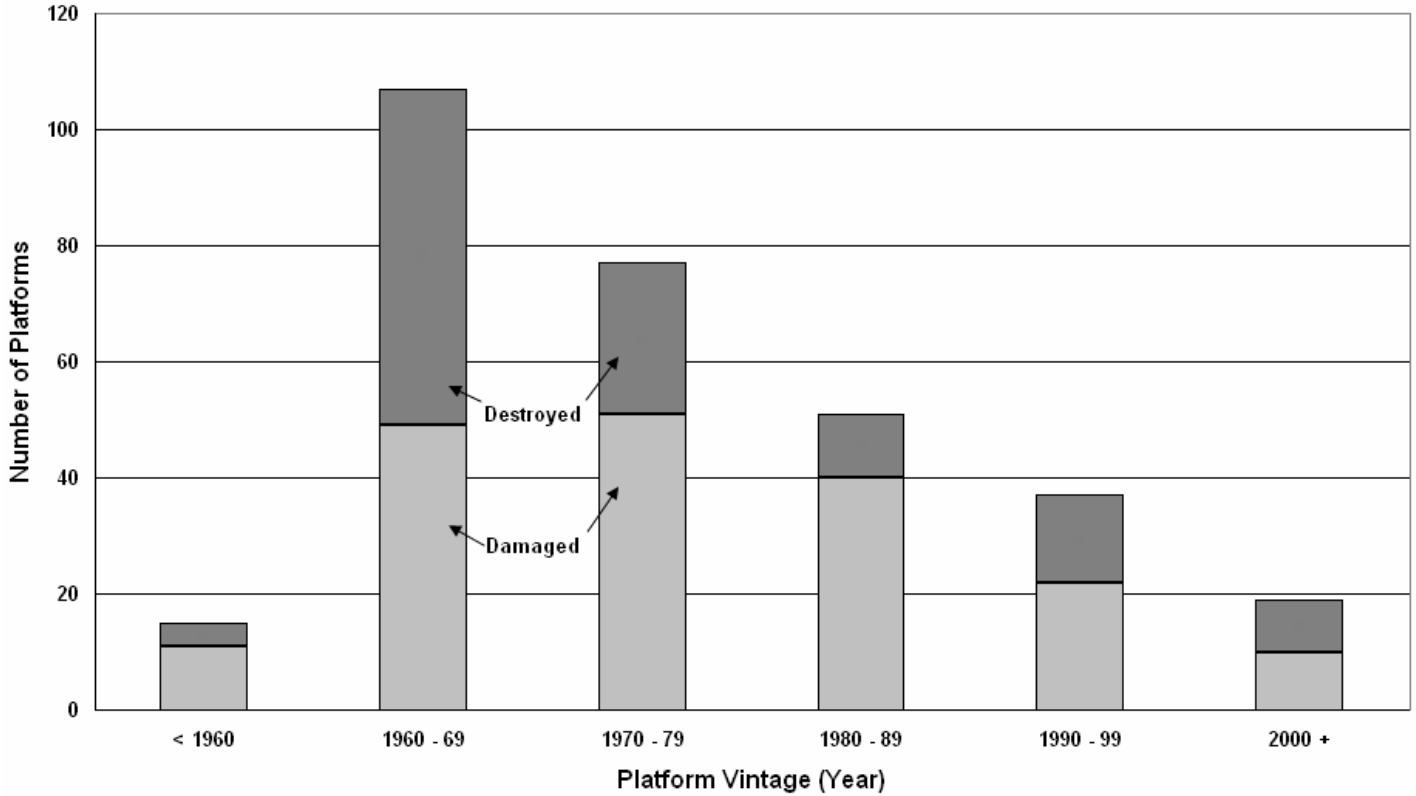
FIGURE 2. NUMBER OF DAMAGED AND DESTROYED PLATFORMS BY VINTAGE – HURRICANES IVAN, KATRINA & RITA

The platforms were divided into categories for destroyed and major damage as a function of decade installed as shown in Figure 2. There are a total of 123 destroyed fixed platforms and approximately 200 damaged platforms. The destroyed platforms have been previously identified by the MMS [MMS, 2006].

Figure 2 shows that the largest concentration of destroyed and damaged platforms were installed in the 1960's and 1970's. This matches well with previous findings of destroyed and damaged platforms from previous Gulf of Mexico hurricanes [Puskar, et.al 1994; Puskar, et.al, 2004; Puskar, et.al. 2006]. The 1960's vintage platforms were designed and installed prior to any industry design standard. These platforms generally had low deck elevations, lacked strengthened connections (joint cans) and in some cases were designed to only a 25 year return period wave. As the industry gained design experience, the first edition of RP2A was developed and published in 1969. This provided an improvement in design as well as fabrication standards. However several key ingredients were still missing, including guidance on minimum deck elevation, a consistent design recipe to determine wave loads, the lack of specific 100 yr design wave heights and limited guidance on design of joints, member slenderness and other platform details. It is therefore no surprise that numerous 1970 vintage platforms were also destroyed and damaged.

Figure 2 shows that 35 platforms were destroyed and 72 platforms were damaged among those that were installed post 1980. This represents a vintage of platforms designed to the post-9<sup>th</sup> edition of RP2A, considered to be the time at which the RP2A platform

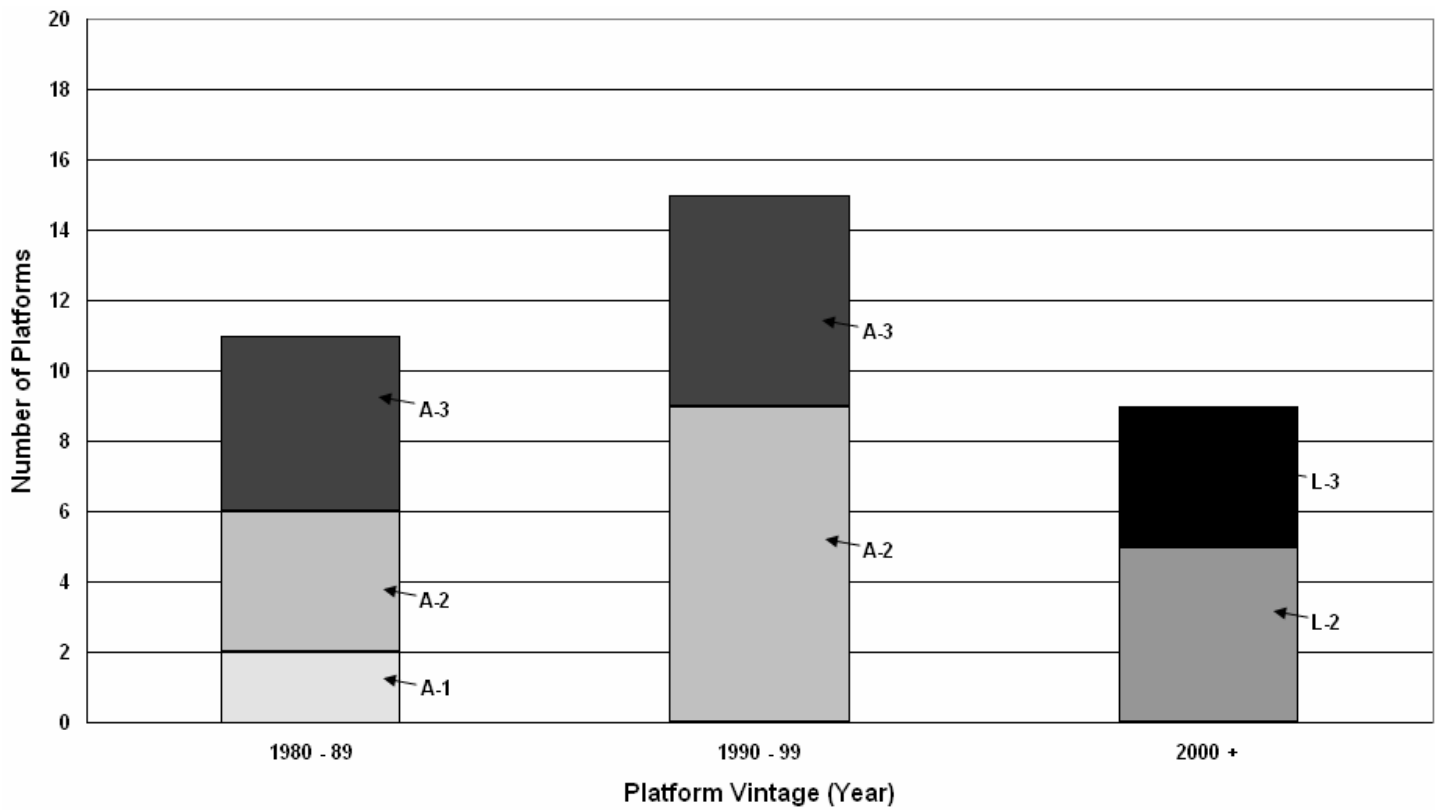
FIGURE 5. MODERN DESTROYED PLATFORMS BY VINTAGE – HURRICANES IVAN, KATRINA AND RITA

Figure 5 shows the 1980's and 1990's destroyed platforms as a function of their RP2A Section 17 assessment categories. There were only two A-1 high consequence platforms destroyed. The remainder are A-2 medium or A-3 low consequence platforms. Note that from 2000 onward, the platforms are classified per RP2A 21<sup>st</sup> edition Section 2 consequence criteria of L-1 high consequence, L-2 medium consequence or L-3 low consequence. The most important observation from this figure is that there were no RP2A 20<sup>th</sup> edition L-1 High Consequence platforms destroyed in the hurricanes. The 20<sup>th</sup> edition was issued in 1993 and included a new, major change to the RP2A wave load recipe, which resulted in a significant increase in the design metocean loading for new platforms (at that time all platforms were considered L-1). The industry began to implement the 20th edition wave load recipe in the mid 1990's. All L-1 platforms used the new wave load recipe from 2000 onward. The fact that none of these L-1 platforms were destroyed in the hurricanes is an indicator of the improved performance of these latest generation RP2A platforms.

There are however several post 2000 platforms that were destroyed, as shown by the nine L-2 and L-3 failures in Figure 5. The 21<sup>st</sup> edition of RP2A introduced the concept of "Consequence Based Design" that allowed platform owners to use a reduced metocean criteria for design that is less than 100 year conditions. The L-2 is a medium consequence structure and the L-3 is a low consequence structure (primarily caissons) with design return periods less than the 100 year conditions for L-1. These alternatives were provided as an option to the more robust L-1 design. As the name "consequence based design" implies, the L-2 and L-3 platforms are

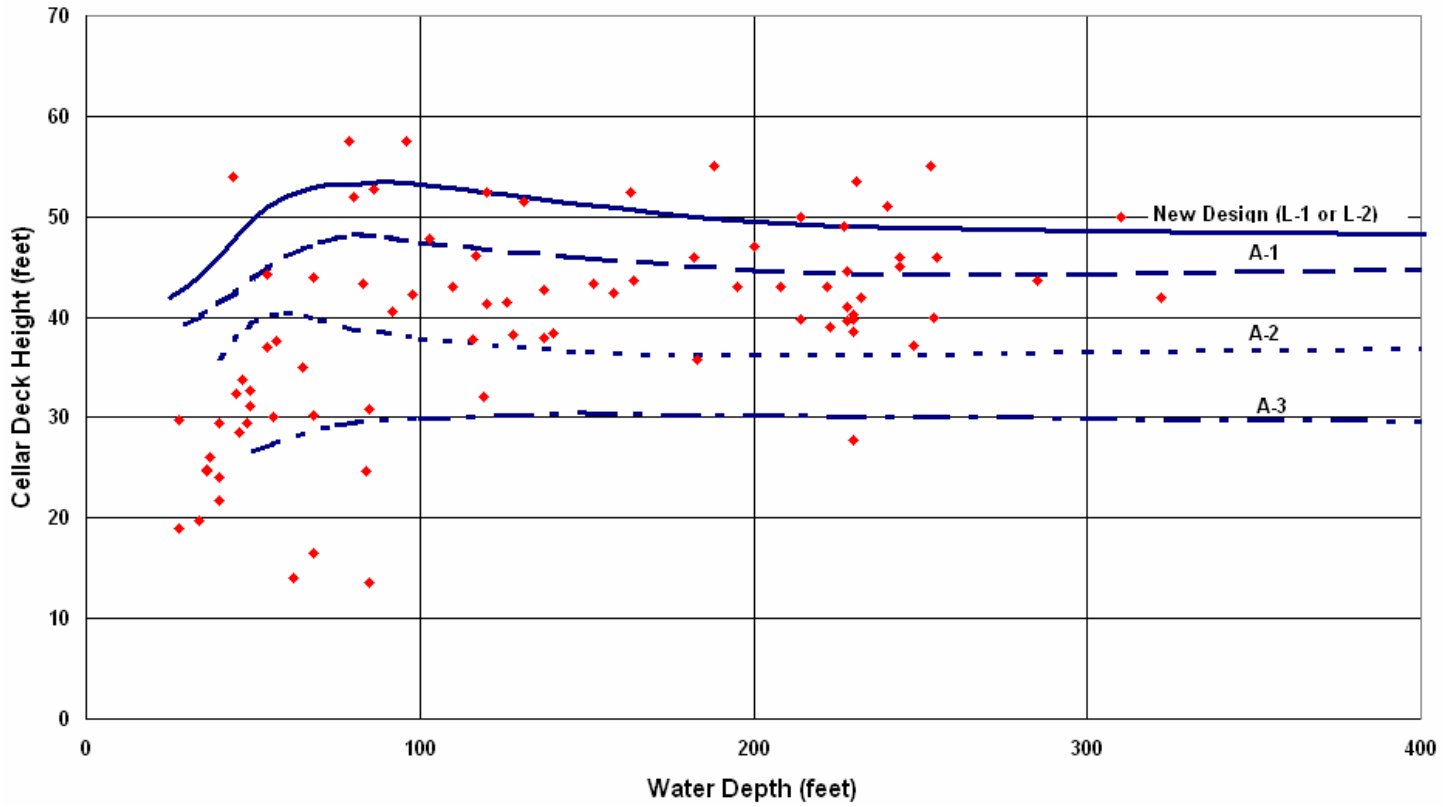
FIGURE 7. DESTROYED PLATFORMS BY DECK HEIGHT – HURRICANES IVAN, KATRINA AND RITA

Figure 7 shows a plot of deck height vs. water depth for 84 of the destroyed platforms where the cellar deck elevation was available. Also shown for comparison are the deck elevation curves for the Section 17 A-1, A-2 and A-3 existing platforms as well as the RP2A Section 2 minimum deck elevation curves for new design platforms. The plot provides a feel for the range of deck elevations among the destroyed platforms. One observation to be drawn from this curve is that a majority of the platforms that were destroyed had deck elevations below the Section 2 minimum deck elevation curve for new design. The A-1 minimum deck elevation curve for high consequence platforms is also above most of the destroyed platform deck elevations. However, the A-2 deck elevation curve is below most of the deck elevations. The A-3 curve is below almost all of the deck elevations. Similar relationships were found for hurricane Ivan [Energco, 2006].

Many operators categorize their platforms as A-2 and use the associated Section 17 guidelines to establish the adequacy of the platform in hurricanes. According to Figure 7, a platform that has a minimum deck elevation above the A-2 criteria but below the A-1 criteria is at risk of damage or destruction in large hurricanes. A better indicator for adequacy is the A-1 and preferably the Section 2 deck elevation curves used for new platform design. Given all of the observed damage to platform decks in these storms, and given the increased risk of platform failure if the deck is hit by a wave, API is considering raising the required minimum deck elevation for new-build platforms. Actual performance of platforms in hurricanes, according to their deck elevations as shown in Figure 7 will be a useful reference to help establish these types of code improvements.
