OTC 17543

Understanding Through Experience – Key Findings From the FPSO Structural Performance Joint Industry Project

C. Serratella, ABS Consulting Inc., and R. Spong, Energo Engineering, Inc.

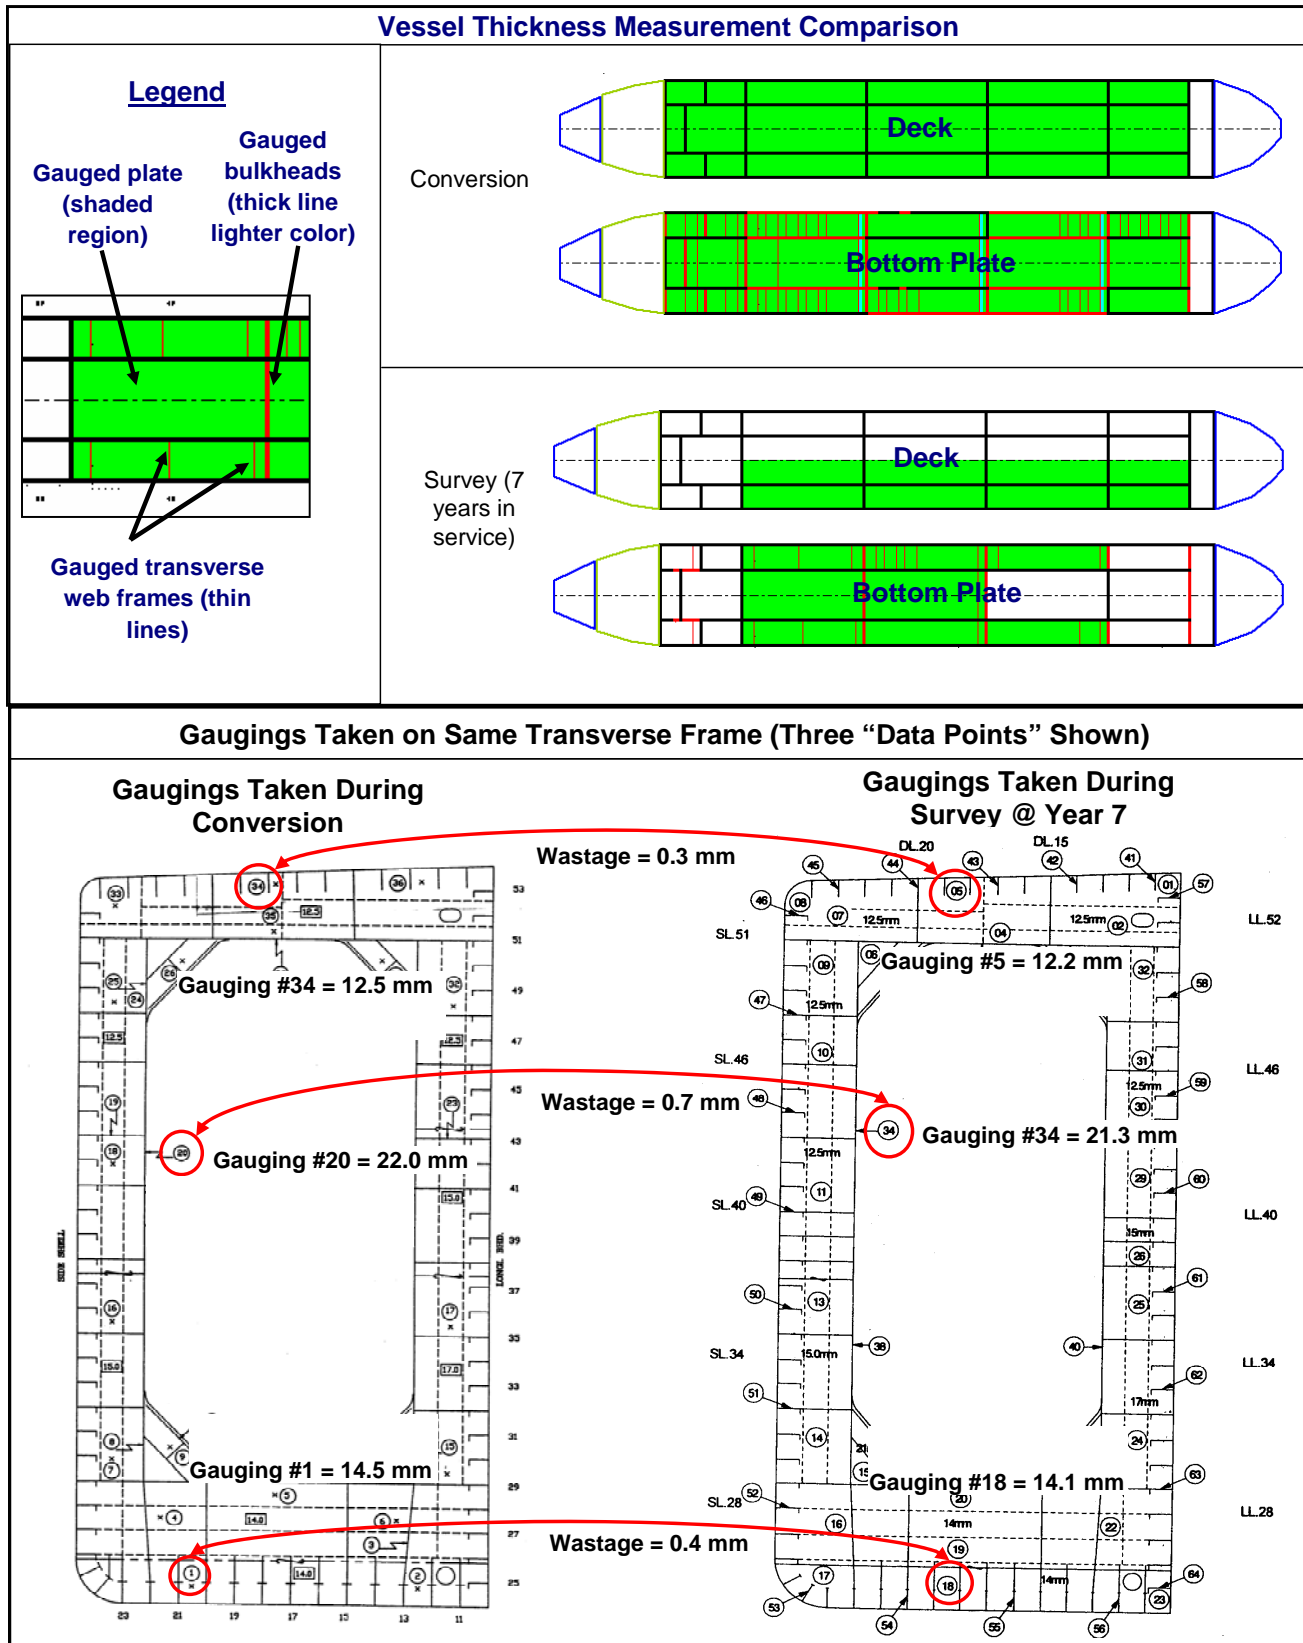
Figure 1: Typical Gauging Data Points Used for Corrosion Rate Estimates

It should also be noted that for some components such as deck and bottom plating, the averages for individual plates are used instead of individual gauging points. This is also shown pictorially in Figure 1.
